**DEPARTMENT OF THE AIR FORCE  
HEADQUARTERS 341ST SPACE WING (AFSPC)**

On 18 May 2001, we received your Freedom of Information Act (FOIA) request dated 9 May 2001, for records pertaining to a March 16, 1967 incident, in which there was a malfunction of missile silos. Copies of excerpts, as well as supporting documents, of the below listed documents are releasable and are attached:

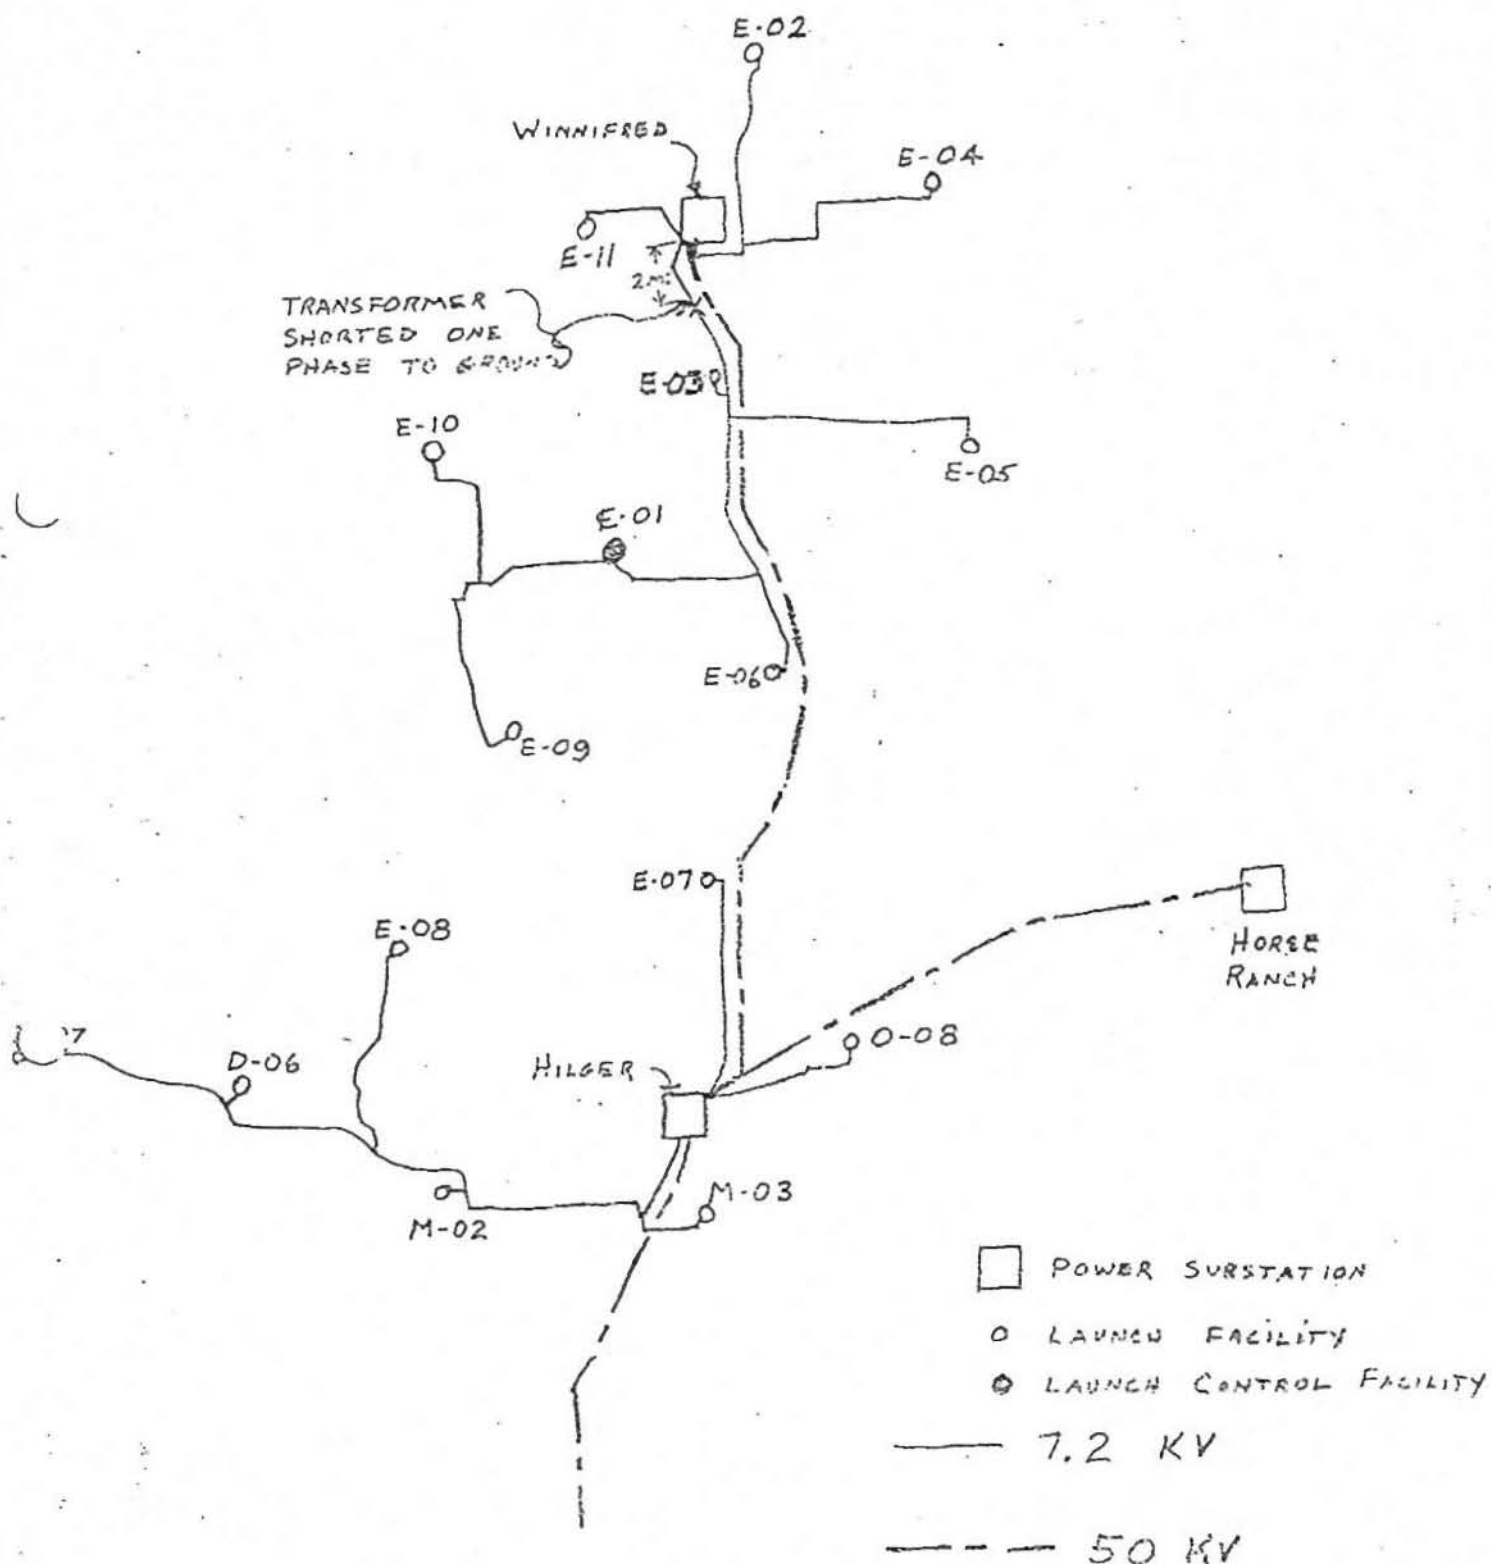
FIGURE 1.

E FLIGHT POWER DISTRIBUTION

A 7.2 KV transformer shorted in the line to site E-3 at 1450, 16 March 67. This transformer is located on a farm two miles south of the Winifred substation. Automatic reclosure switches at Winifred substation opened, and were reclosed manually after transformer replacement later in the day. This caused the Brine Chiller problem at E-1. The transformer was in the West phase. It was not determined which phase this corresponds to at the sites. Sites E-3, E-5, E-6, E-9, and E-10 transferred to Standby Power. Sites E-1 transferred to Direct Current (DC) <sup>92</sup> operation. (U)

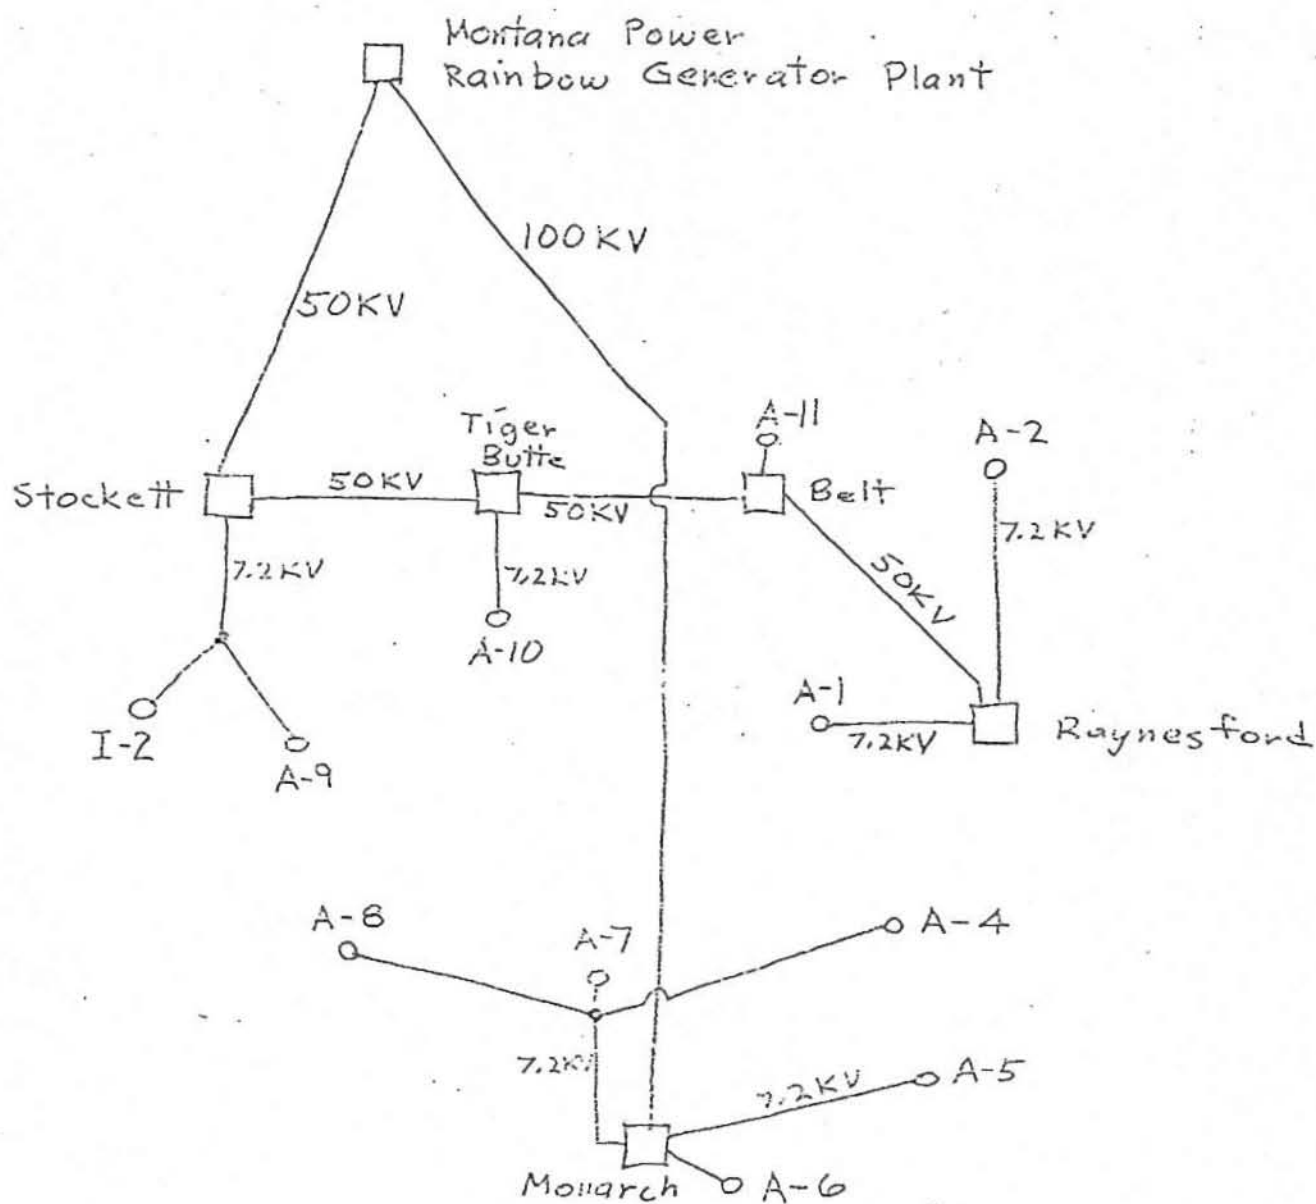
A FLIGHT POWER DISTRIBUTION  
FIGURE 3.

December 1966. On 19 December 66, A Flight had some of it's  
LFs shutdown (A-6, A-7, and A-10). The similarity between the  
two flights was: The same Capsule crew, adverse weather con-  
ditions, and commercial power failure after the facilities  
shutdown. <sup>88</sup> (U)
