**NEW ZEALAND DEFENCE FORCE**

**UNIDENTIFIED FLYING OBJECTS (UFO) FILES**

**File Title:** Investigations of Unidentified & Radar Sightings  
East Coast South Island – December 1978

**File Contains:** Interviews with people involved in the 1978 Kaikoura sightings conducted by the RNZAF preparatory to the preparation of a formal report into these sightings. File also contains technical reports from DSIR and other scientific experts and an independent report of the Kaikoura sightings by the NZ UFO Studies Centre.

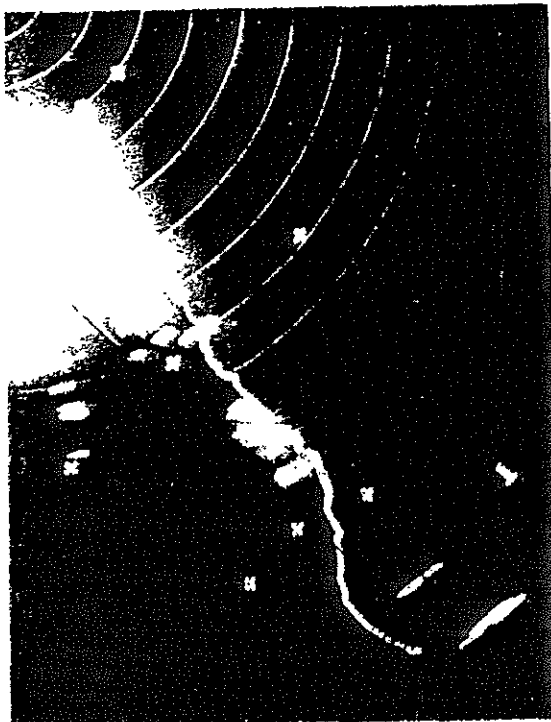
0338. RAW VIDEO. 160 MI.  
BANKS PENINSULA RETURN  
AT MAX<sup>m</sup> RANGE

TWO ANOMALOUS ECHOES  
15 MI. NORTH OF BANKS P.

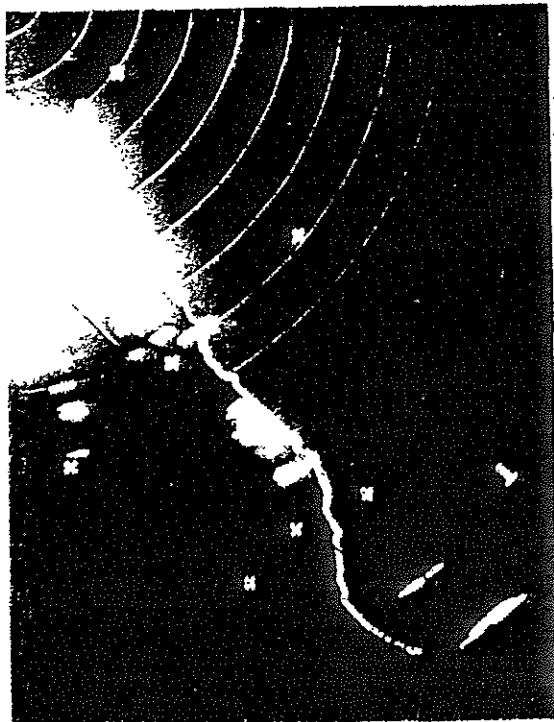
0330. RAW VIDEO. 160 MI.

BANKS PENINSULA RETURN  
AT MAX<sup>m</sup> RANGE

TWO ANOMALOUS ECHOES  
15 MI. NORTH OF BANKS P.

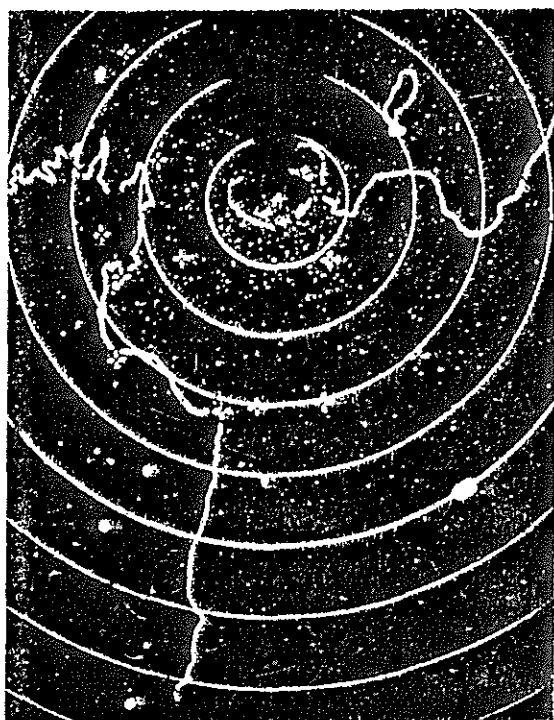
0436. M.T.I. 10 MI CIRCLES

SHIP OFF SOUNDS 36 MI.

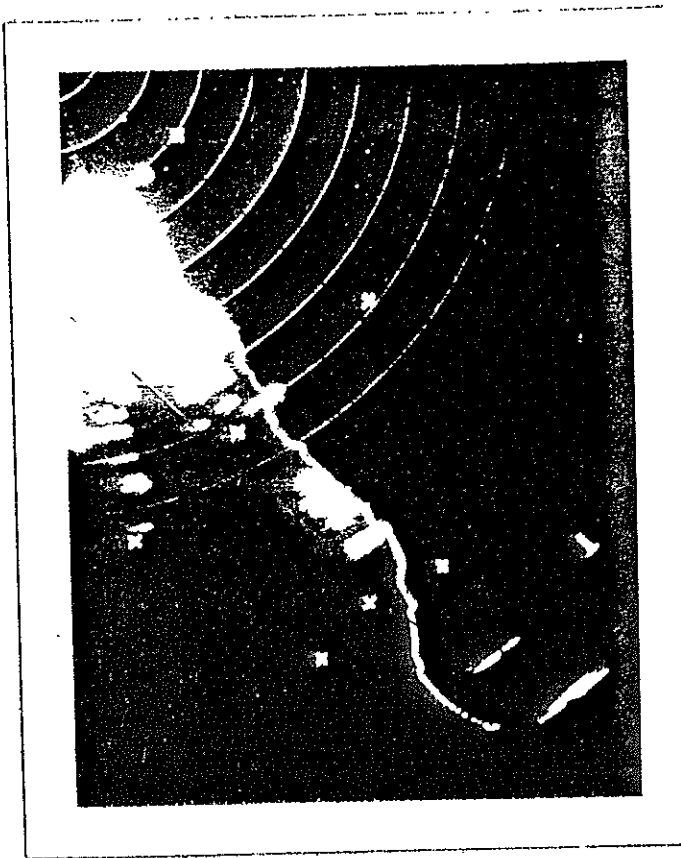
0338, RAW VIDEO. 160 MI.

BANKS PENINSULA RETURN  
AT MAX<sup>m</sup> RANGE

TWO ANOMALOUS ECHOES  
15 MI. NORTH OF BANKS P.

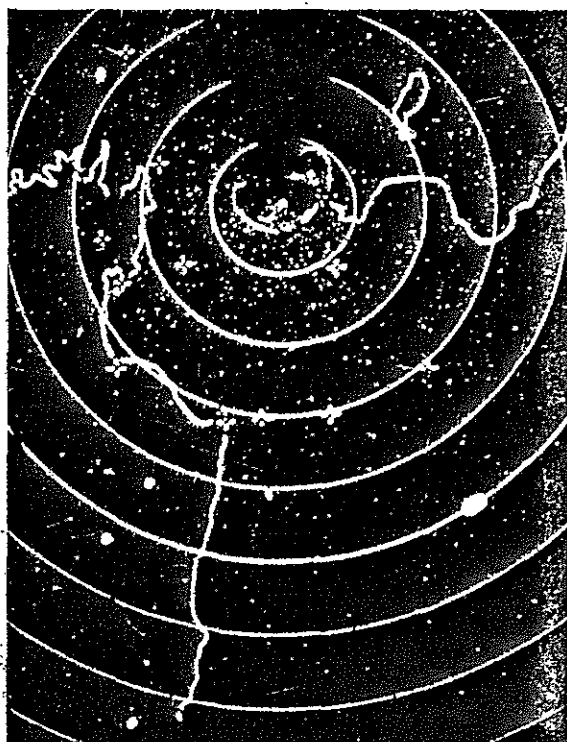
0436. M.T.I. 10 MI CIRCL

SHIP OFF SOUNDS 36 MI.
