**DEPARTMENT OF THE AIR FORCE  
HEADQUARTERS 341ST SPACE WING (AFSPC)**

On 18 May 2001, we received your Freedom of Information Act (FOIA) request dated 9 May 2001, for records pertaining to a March 16, 1967 incident, in which there was a malfunction of missile silos. Copies of excerpts, as well as supporting documents, of the below listed documents are releasable and are attached:

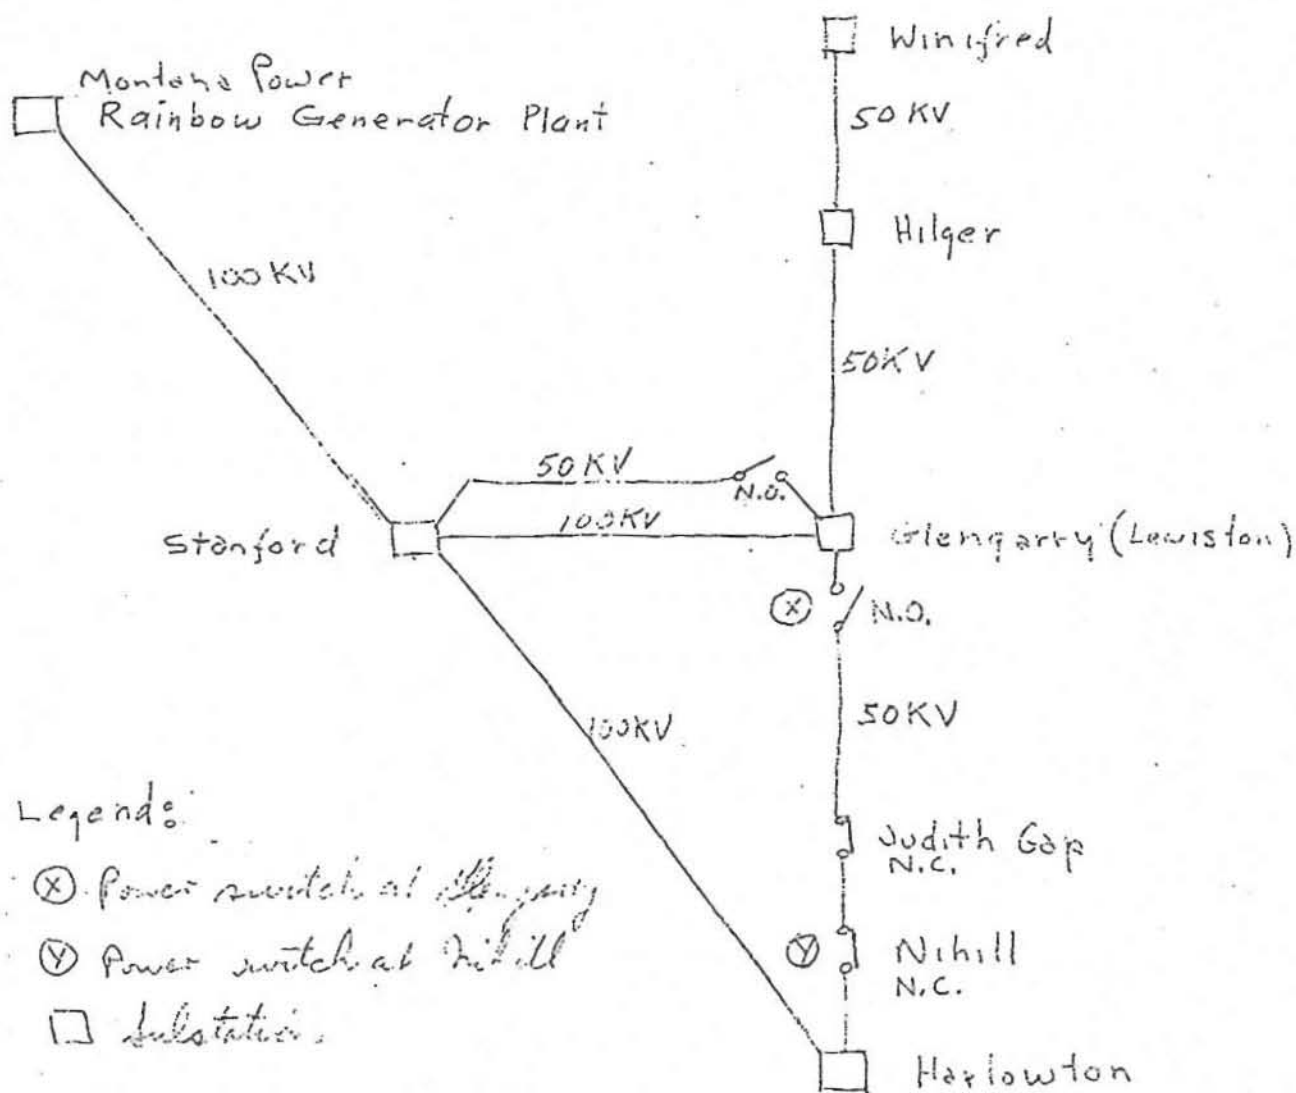
FIGURE 1.

E FLIGHT POWER DISTRIBUTION

A 7.2 KV transformer shorted in the line to site E-3 at 1450, 16 March 67. This transformer is located on a farm two miles south of the Winifred substation. Automatic reclosure switches at Winifred substation opened, and were reclosed manually after transformer replacement later in the day. This caused the Brine Chiller problem at E-1. The transformer was in the West phase. It was not determined which phase this corresponds to at the sites. Sites E-3, E-5, E-6, E-9, and E-10 transferred to Standby Power. Sites E-1 transferred to Direct Current (DC) <sup>92</sup> operation. (U)
