5. Metallographic Analysis

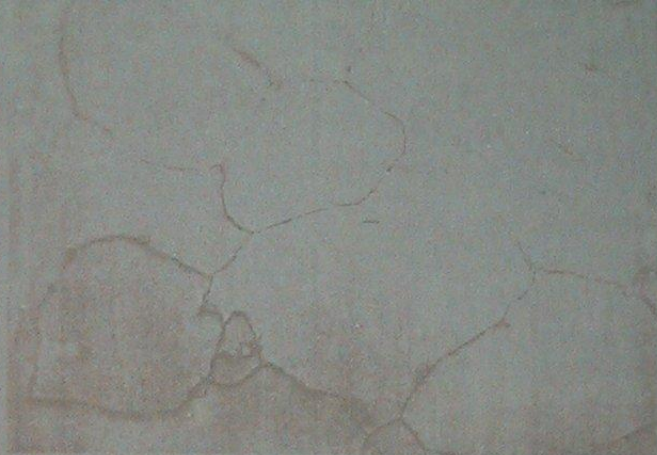
#1

X350

with "Universal  
Etchant"

- a) The photomicrograph taken at low magnification shows the structure of the alloy at low magnification. The matrix is the  $\delta$  phase and the precipitate is the phase  $\epsilon$ . Note the large grains.
- b) This photomicrograph, taken at higher magnification, shows the matrix  $\delta$  and the thinner  $\epsilon$  phase both brown and in the grain. Also observe the aligned lines (Lüders lines) in the matrix.

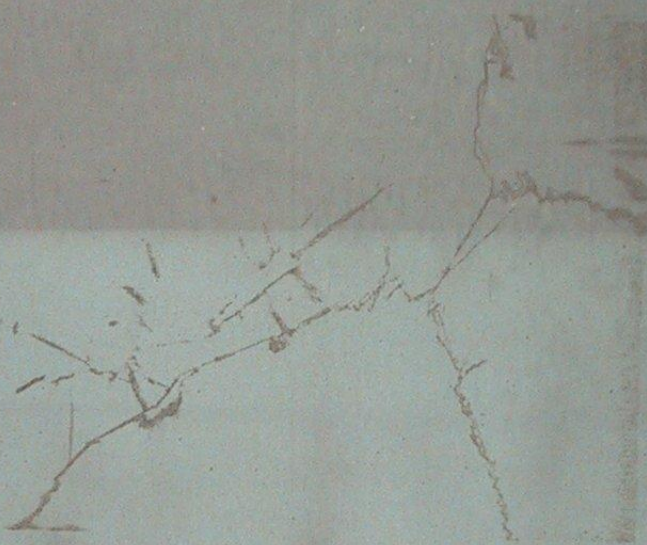
#2

X1000

Electropolished  
and etched  
with "Universal  
Etchant"
